# Manhole Inspection Summary

Manhole # S59I\_\_016MH

Insp Date: **5/19/08 2:23 PM**

**Location** Address: **424 s lehigh st**

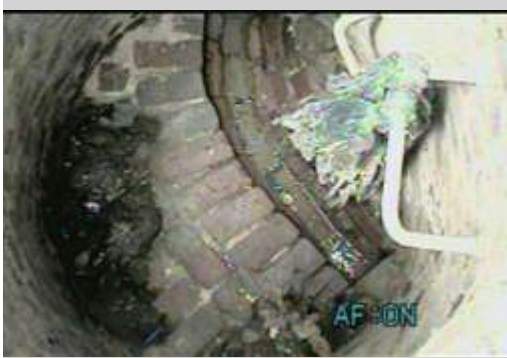
Defect 2

**Steps** Count: **3** Missing: **0** ☒ **Corroded**

steps

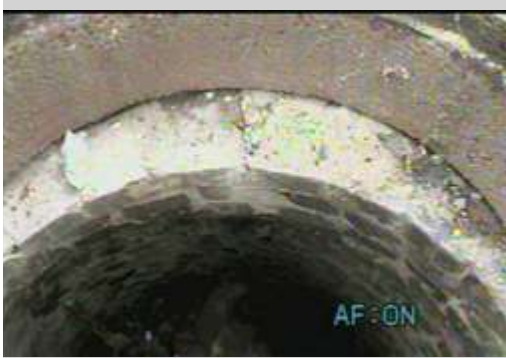
Defect 1

**Frame** Offset: **4** (in.) Condition: ☒ Sound ☐ Cracked ☐ Leaks

offset

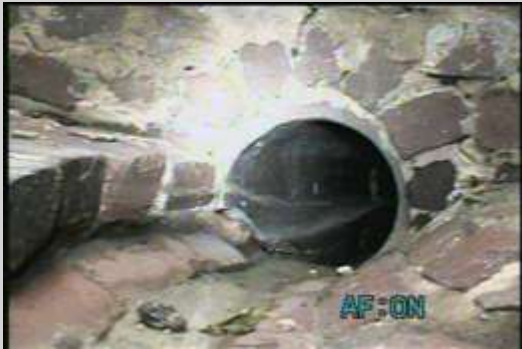
12 O'Clock Outflow

8 in. Circular Gravity Sewer  
Pipe Out @ 12 O'Clock

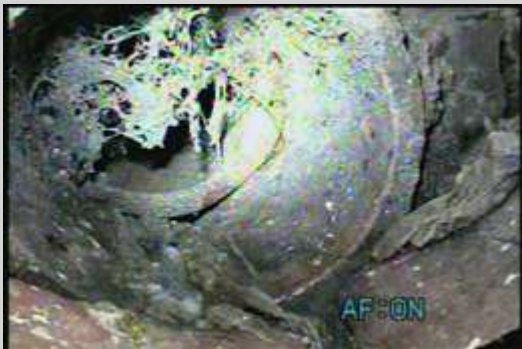
3 O'Clock Inflow

8 in. Circular Gravity Sewer  
Pipe In @ 3 O'Clock

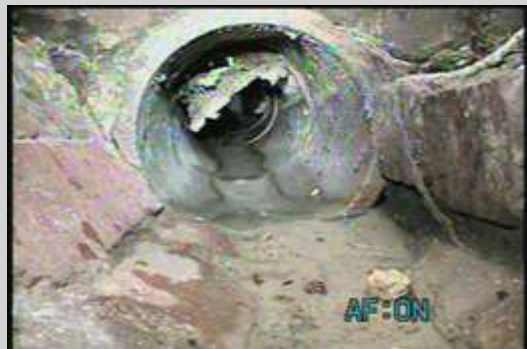
4 O'Clock Inflow

8 in. Circular Gravity Sewer  
Pipe In @ 4 O'Clock
